NORTH DAKOTA FOREST SERVICE

FOREST RESOURCE MANAGEMENT PLAN

Owner(s): City of Grand Forks
Address:

Date: April 15, 2003
Telephone:

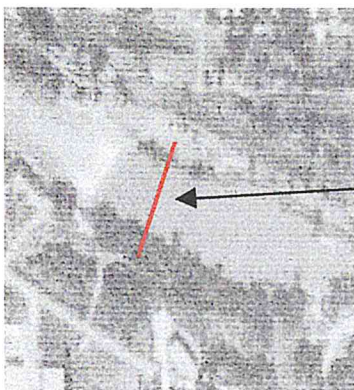
Figure 4: River Reach

The river through this reach is in good condition. They are well vegetated and there was little erosion occurring. The banks alongside the dam are heavily armored with riprap to prevent erosion when the fast moving waters reach flood conditions.

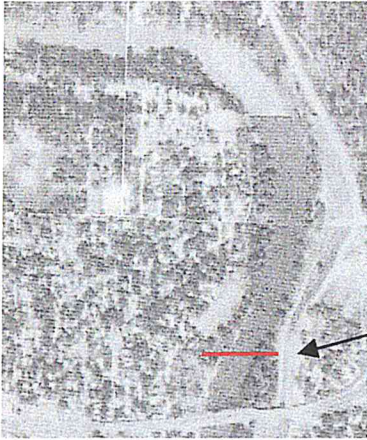
Figure 6: River Reach

The riverbanks through this reach are in good condition. The banks are well vegetated and stable with little erosion occurring and cutbanks are small.

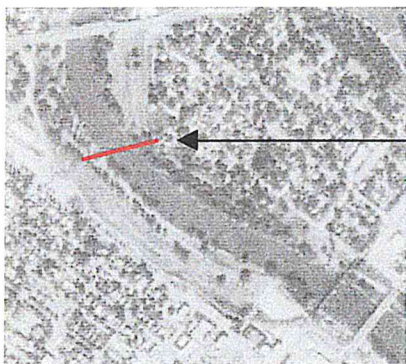
Figure 8: River Reach

The riverbank is in excellent condition through this reach. The large cottonwood and elm trees that have been growing along the river through this reach have been providing good stability to the riverbank. There are no cutbanks found on this reach and very little erosion.

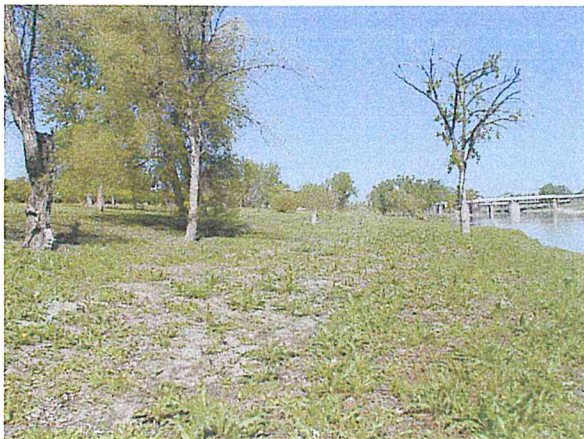
This stand is located in between the DeMers Ave. Bridge and the Minnesota Ave. Bridge. There is no native forest through this reach. The ground is vegetated by mainly sedges. The site is not totally devoid of woody vegetation as the city has been planting trees on the riverbank.

The area has been mowed in the past, this mowing has been limiting the amount of woody vegetation that can become established on the site.

This stand should be protected from destructive cutting, clearing, fire, mowing and compaction. Cooperation with the local fire department and adjacent property owners will limit the chances of a wildfire. Although the moist, shady conditions in well developed, riparian areas are not usually a great fire risk.

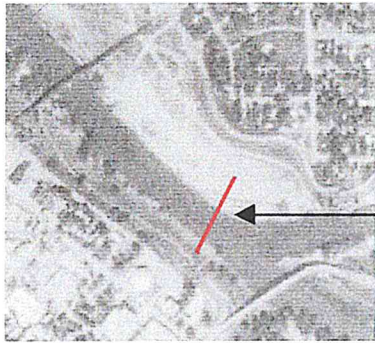
Figure 10: River Reach

The riverbank is in excellent condition through this reach. Although some woody vegetation would help to buffer the runoff before it gets to the river, the banks are very stable and establishing woody vegetation may not be necessary.

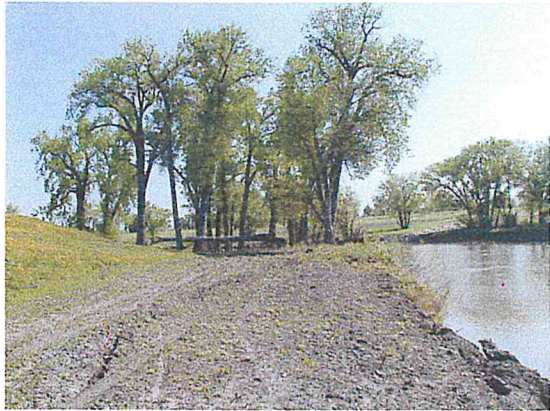
This area is known as Central Park. The riparian forest cover consists of a very narrow band of cottonwood along the river. Much of this reach is not vegetated at all because of recent disturbances, including, flooding, mowing, and cultivation. No sapling sized trees are present. There is very good sandbar willow growth on the north end of the stand. The large cottonwood trees present on the site are overmature and beginning to decline. Once these trees are gone, there will be no mature forest cover on the site.

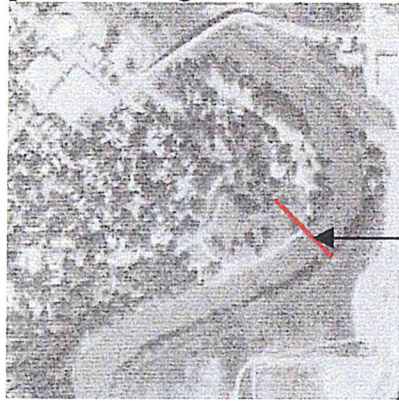
Figure 12: River Reach

The riverbank through this reach is experiencing some erosion. Small cutbanks of a few feet are present through most of the reach. The south side of the reach has been mowed and disturbed.

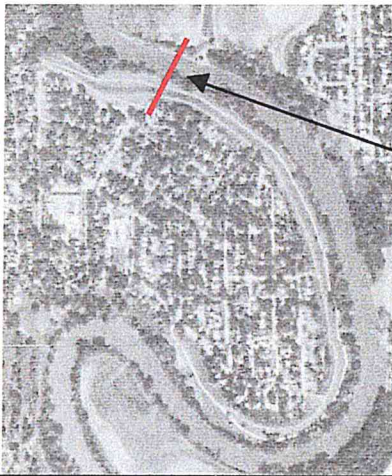
Figure 14: River Reach

The riverbank through this reach is in good condition. There are small cutbanks found throughout the reach, but it is well vegetated and fibrous rooted willows are rapidly becoming established.

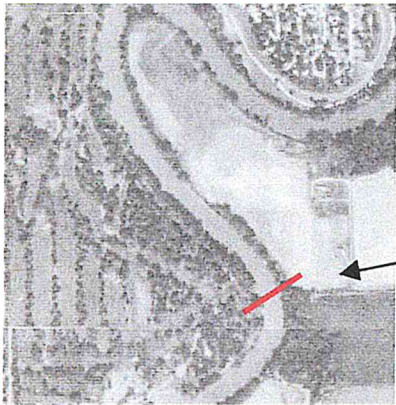
Figure 16: River Reach

The riverbanks through this reach are very well vegetated and are in good condition, although steep cutbanks can be found throughout much of the reach. It is expected that the banks will continue to cave into the river until a stable slope is reached naturally. The large cottonwood trees found along the riverbank provide valuable stability to the riverbank, and future cottonwood establishment should be encouraged.

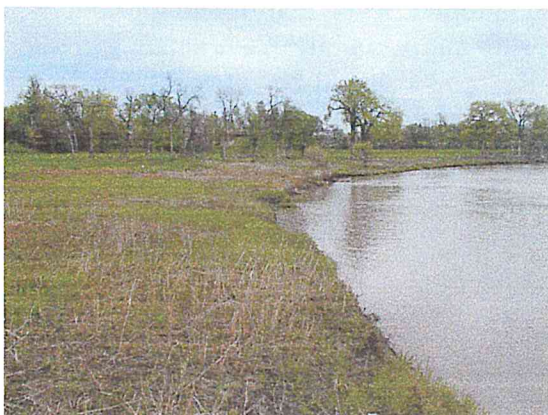
This reach of the riverbank is about 450 feet long. It is void of any woody vegetation except for a small patch of sandbar willow and a few damaged trees along the waters edge.

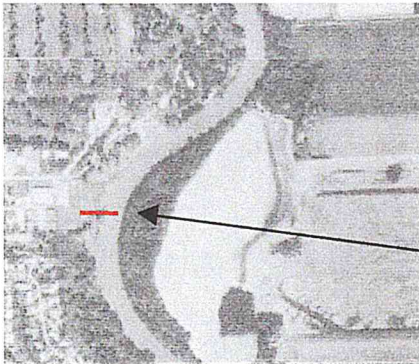
Figure 18: River Reach

The riverbank through this reach is in good condition. It appears as though this area is used by people fishing from shore. Foot traffic in this area could be very detrimental to the development of the trees and shrubs.

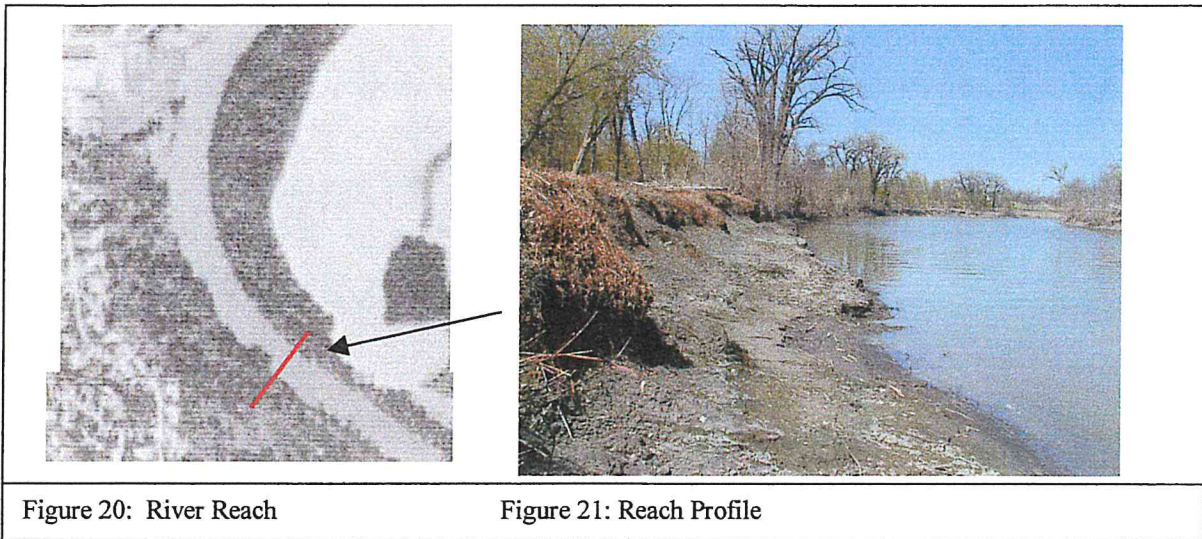
Figure 20: River Reach

The riverbank through this reach is in good condition. The trees of this stand provide excellent stability to the bank. The trees also help to reduce erosion during flood conditions, and the root systems are reducing erosion at several points along the bank.

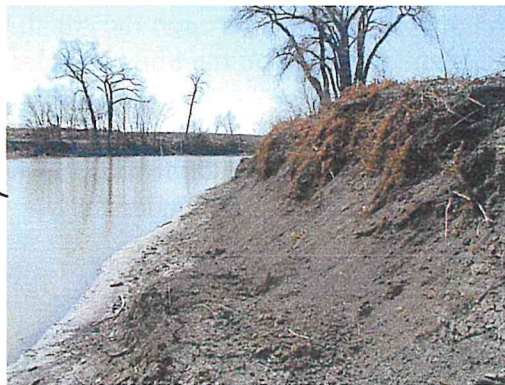
Figure 23: Reach Profile

As can be seen in figure 14, the reach profile the riverbanks through this reach consist mainly of steep cutbanks that are around 10 feet high. These banks are unstable and will continue to fall into the river until a stable slope is reached. There is some woody vegetation present in the form of scattered large cottonwood trees and scattered patches of sandbar willow.

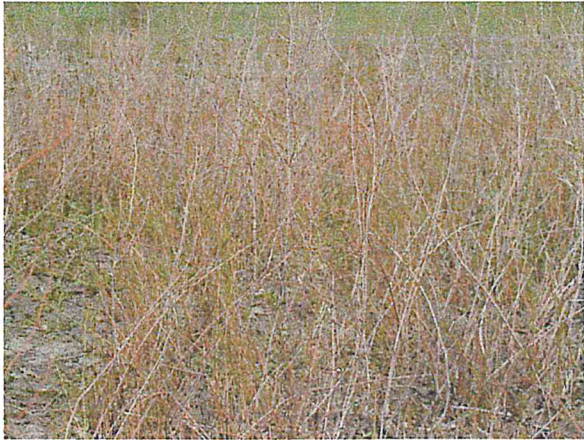
A patch of sandbar willow is developing on the north side of the area. This is the type of riparian vegetation that should be encouraged on this site, and others along the entire reach, in order to help stabilize the riverbanks and provide other important riparian benefits. Willow cuttings could be harvested from this area and transplanted to other areas along the bank. To the left is a picture of this patch of sandbar willow. This patch of willow starts growing at the waters edge and continues up the bank about 50 feet.

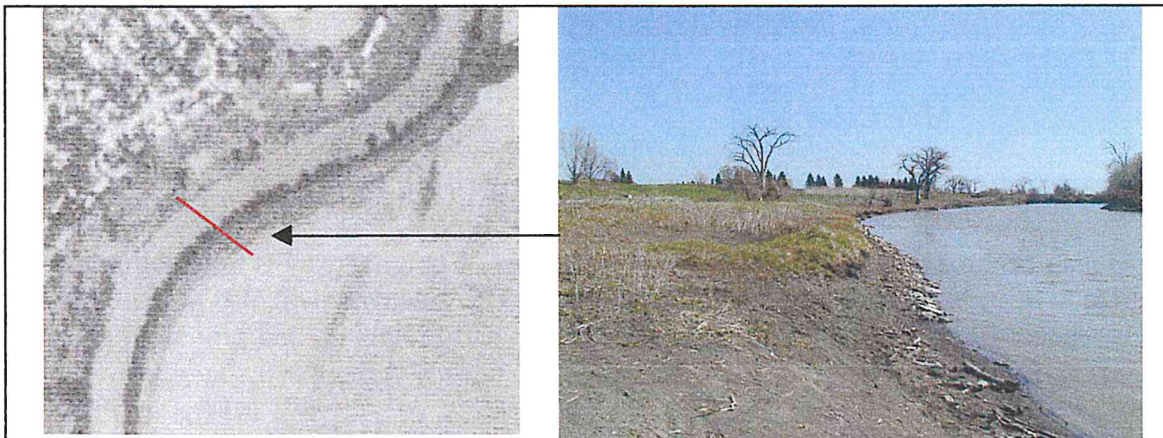
Figure 24: River Reach

The riverbank is in good condition through this reach. There is a small cut bank, which could be stabilized through the use of flood tolerant woody vegetation.

It is recommended to establish a woody corridor of riparian plant species along the riverbank through this reach. When planning a planting, it is important to observe the locations of the existing vegetation with respect to their locations in relation to the stream and water table. Attempt to match the species you plant with the native woody species and their preferred

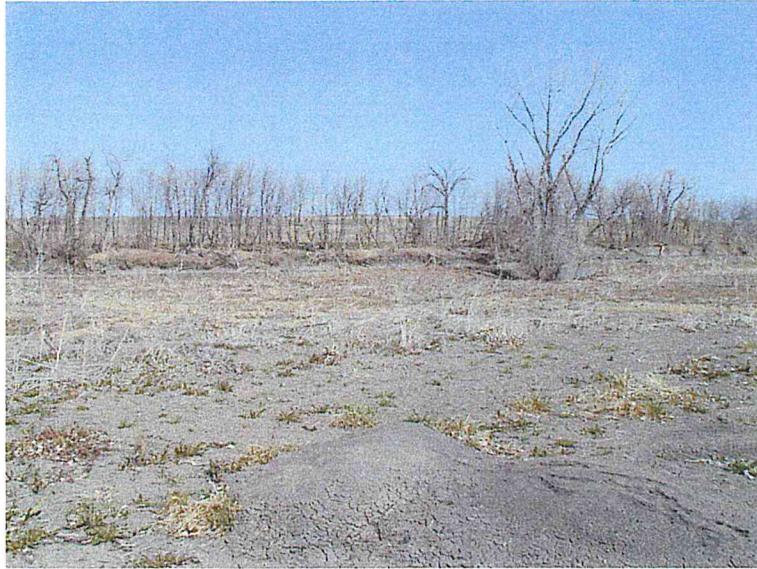
The picture to the left shows the condition of the planting site. It was very open at the time the picture was taken, but annual weeds can be expected to take over the site during this summers growing season.

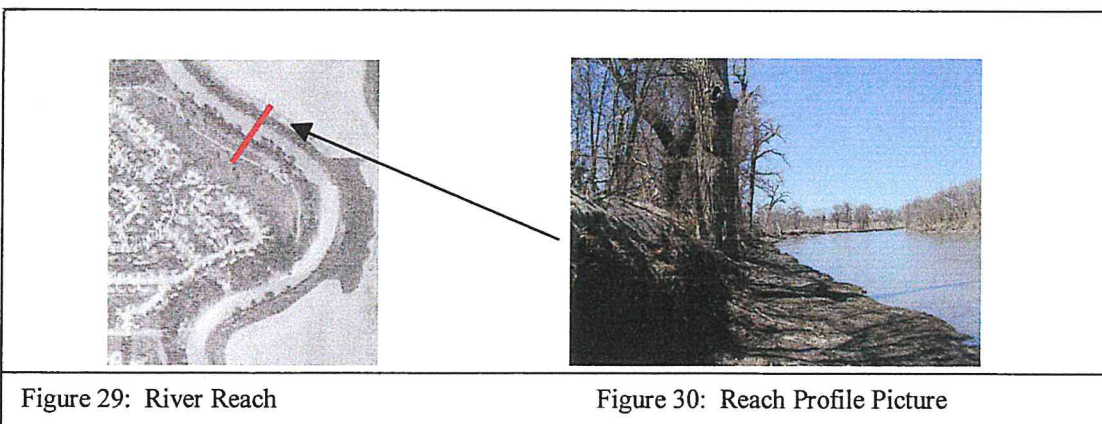
Figure 29: River Reach

The riverbank through this reach of river is in poor condition. It lies on the inside of a large meander. Much of the area directly adjacent to the river is characterized by high cutbanks that are typical along the Red. In areas where large cottonwood trees are growing there has been less soil eroding into the river and the banks are more stable. The forest along this reach of river is very narrow, and not developed enough to provide adequate bank stabilization during high water events. There has been some beaver activity along the reach, but they have not been so active as to be destructive.
