NORTH DAKOTA FOREST SERVICE

FOREST RESOURCE MANAGEMENT PLAN

Owner(s): City of Grand Forks
Address:

Date: April 15, 2003
Telephone:

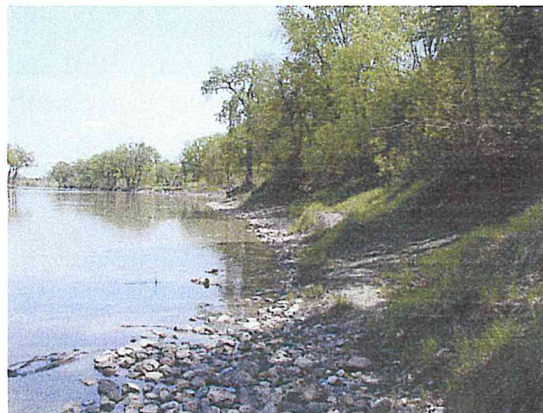
Figure 5: Reach Profile

The river through this reach is in good condition. They are well vegetated and there was little erosion occurring. The banks alongside the dam are heavily armored with riprap to prevent erosion when the fast moving waters reach flood conditions.

This stand should be protected from destructive cutting, clearing, fire, mowing and compaction. Cooperation with the local fire department and adjacent property owners will limit the chances of a wildfire. Although the moist, shady conditions in well developed, riparian areas are not usually a great fire risk.

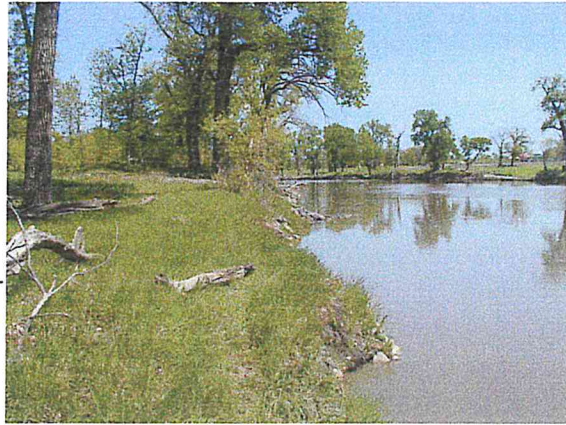
Figure 7: Reach Profile

The riverbanks through this reach are in good condition. The banks are well vegetated and stable with little erosion occurring and cutbanks are small.

This stand should be protected from destructive cutting, clearing, fire, mowing and compaction. Cooperation with the local fire department and adjacent property owners will limit the chances of a wildfire. The moist, shady conditions common in well developed riparian areas are not usually a great fire risk.

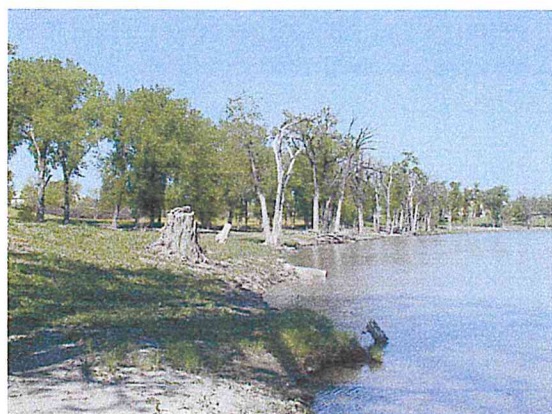
This stand consists entirely of large, mature cottonwood, with no understory trees or natural regeneration. Sedges are becoming established in some of the open areas. Dutch elm disease has killed all of the mature elm trees that were once found in the stand.

Some of the cottonwoods right next to the river are declining. These trees have been stressed by recent summer flooding.

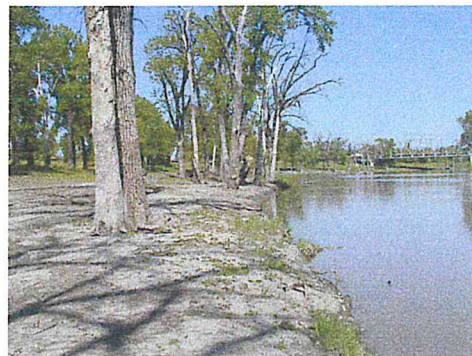
Figure 9: Reach Profile

The riverbank is in excellent condition through this reach. The large cottonwood and elm trees that have been growing along the river through this reach have been providing good stability to the riverbank. There are no cutbanks found on this reach and very little erosion.

This stand should be protected from destructive cutting, clearing, fire, mowing and compaction. Cooperation with the local fire department and adjacent property owners will limit the chances of a wildfire. Although the moist, shady conditions in well developed, riparian areas are not usually a great fire risk.

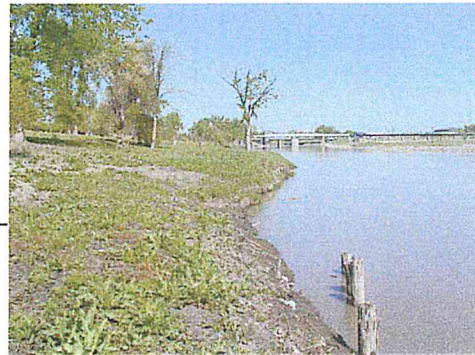
Figure 11: Reach Profile

The riverbank is in excellent condition through this reach. Although some woody vegetation would help to buffer the runoff before it gets to the river, the banks are very stable and establishing woody vegetation may not be necessary.

This stand should be protected from destructive cutting, clearing, fire, mowing and compaction. Cooperation with the local fire department and adjacent property owners will limit the chances of a wildfire. Although the moist, shady conditions in well developed, riparian areas are not usually a great fire risk.

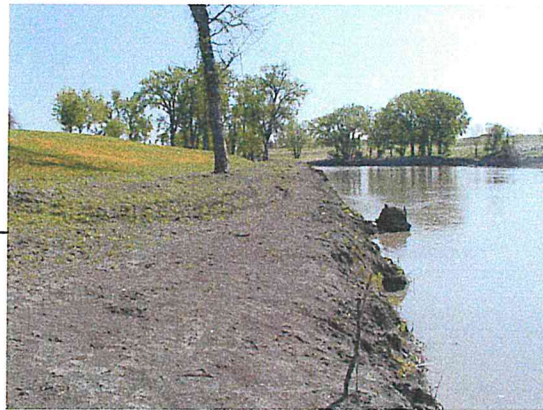
Figure 13: Reach Profile

The riverbank through this reach is experiencing some erosion. Small cutbanks of a few feet are present through most of the reach. The south side of the reach has been mowed and disturbed.

This stand should be protected from destructive cutting, clearing, fire, mowing and compaction. Cooperation with the local fire department and adjacent property owners will limit the chances of a wildfire. Although the moist, shady conditions in well developed, riparian areas are not usually a great fire risk.

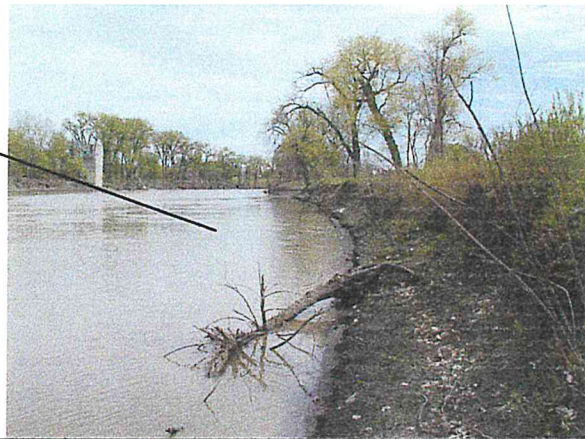
Figure 15: Reach Profile

The riverbank through this reach is in good condition. There are small cutbanks found throughout the reach, but it is well vegetated and fibrous rooted willows are rapidly becoming established.

This stand should be protected from destructive cutting, clearing, fire, and compaction. Any harvesting of forest products should be overseen by a forestry professional to ensure that it is being done in a sustainable manner. Cooperation with the local fire department and adjacent property owners will limit the chances of a wildfire. Although the moist, shady conditions in well developed, riparian areas are not usually a great fire risk.

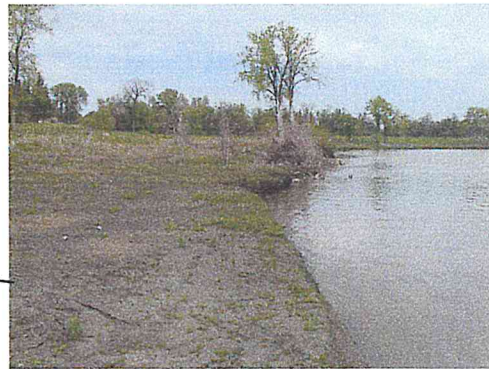
Figure 19: Reach Profile

The riverbank through this reach is in good condition. It appears as though this area is used by people fishing from shore. Foot traffic in this area could be very detrimental to the development of the trees and shrubs.

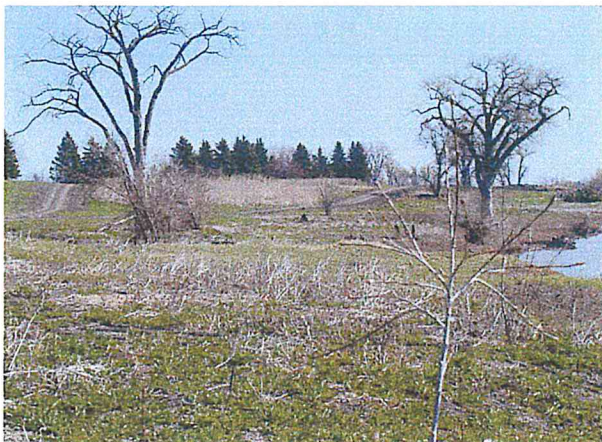
This portion of the greenway is mostly free of forested cover. There are only a few scattered mature cottonwood and elm trees found here. Sedges are becoming established and should slowly out-compete the weedy growth that has developed on the frequently flooded areas. There is some scattered regeneration of cottonwood found along the river.

1. Establish woody vegetation along riverbank.

It is recommended to establish a woody corridor of riparian plant species along the riverbank through this reach. When planning a planting, it is important to observe the locations of the existing vegetation with respect to their locations in relation to the stream and water table. Attempt to match the species you plant with the native woody species and their preferred

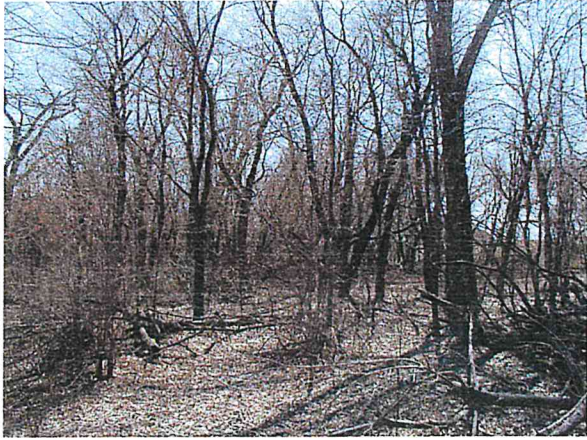
This stand contains a nice mix of bottomland hardwood trees. Trees found within the stand include green ash, boxelder, American elm, and cottonwood. While this stand does contain a mix of age classes, boxelder trees of about 35 years of age dominate the stand. Tree sizes range from 2-inch diameter saplings to 30 inch and larger diameter cottonwood.

The overstory of this stand contains many large trees that range from mature to overmature and declining. The large overstory trees form a closed canopy that creates intense shade on the forest floor. Fungal heart rot was seen in many of the overmature trees, especially the green ash, cottonwood, and boxelder.

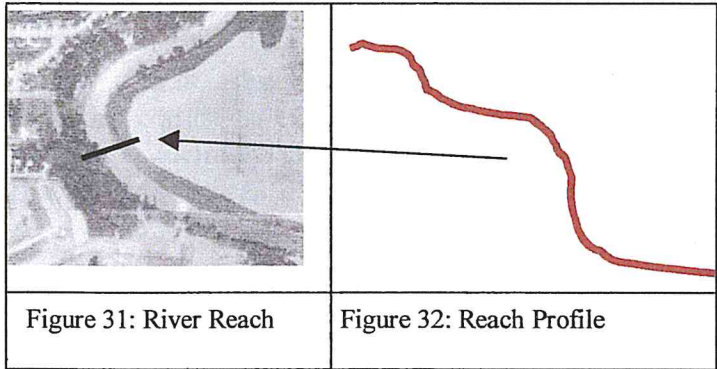
The riverbank through this reach of river is in fair condition. Much of the reach is characterized by high cutbanks. In areas where large cottonwood trees are growing there has been less soil eroding into the river. This is typical of most riverbanks along the Red. This reach of river is

very well vegetated with a healthy riparian forest. There has been some beaver activity along the reach, but they have not been so active as to be destructive.
